# Inspection Report

**Aspen Inspections, LLC**

<b>Date:</b> 4/5/2016	<b>Time:</b>	<b>Report ID:</b>
<b>Property:</b>	<b>Customer:</b>	<b>Real Estate Professional:</b>

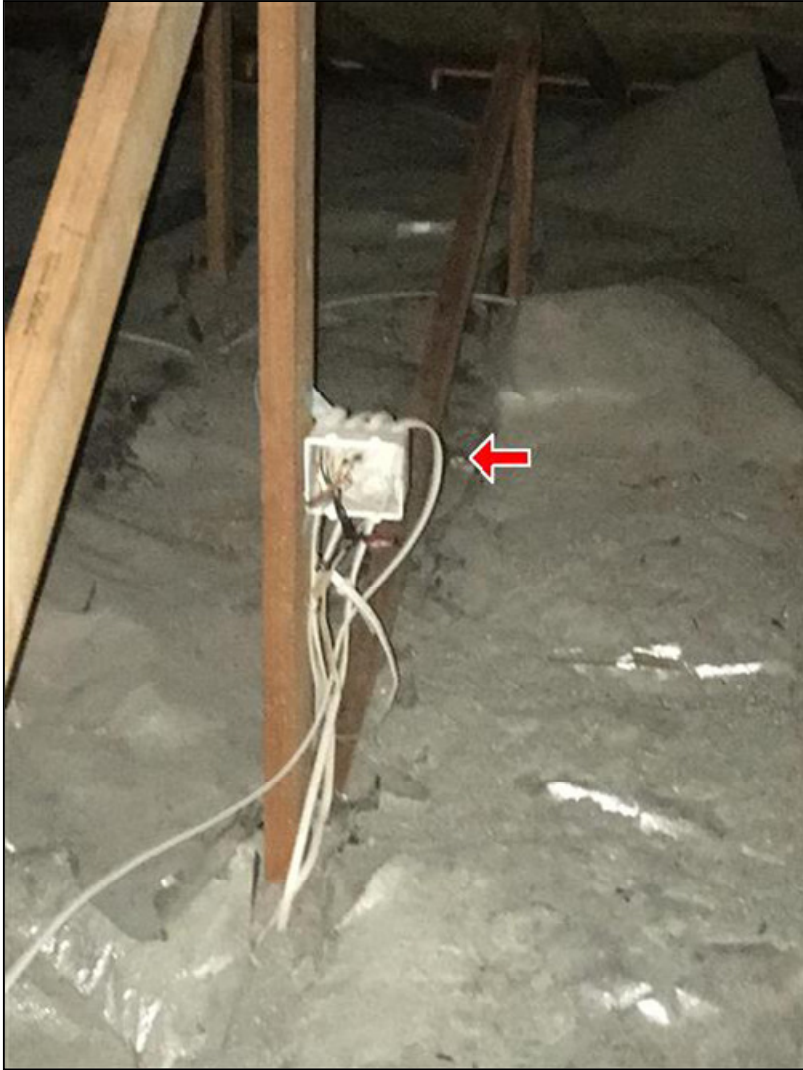
**1.8** There was an open junction box with wires hanging out in the attic. This box needs a cover on it so that potential sparks will be contained in the box. Further evaluation is recommended by a licensed electrician.

1.8 Item 1(Picture) open junction box

There was an open junction box with wires hanging out in the attic. This box needs a cover on it so that potential sparks will be contained in the box. Further evaluation is recommended by a licensed electrician.

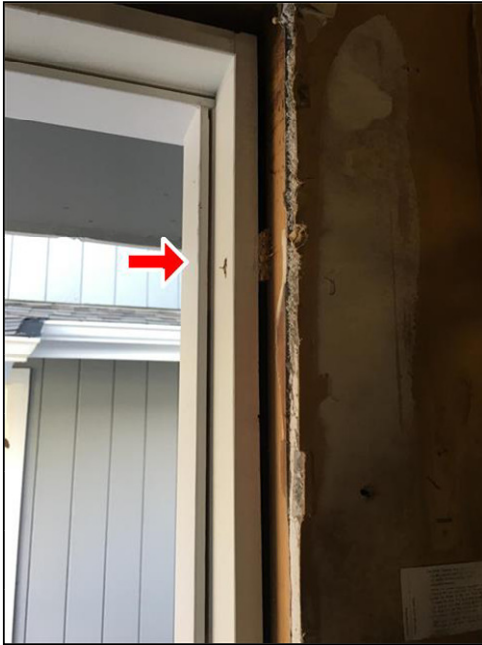
The garage door is missing the weather stripping in the door jamb.

2.1 Item 1(Picture) missing weather stripping in garage service door

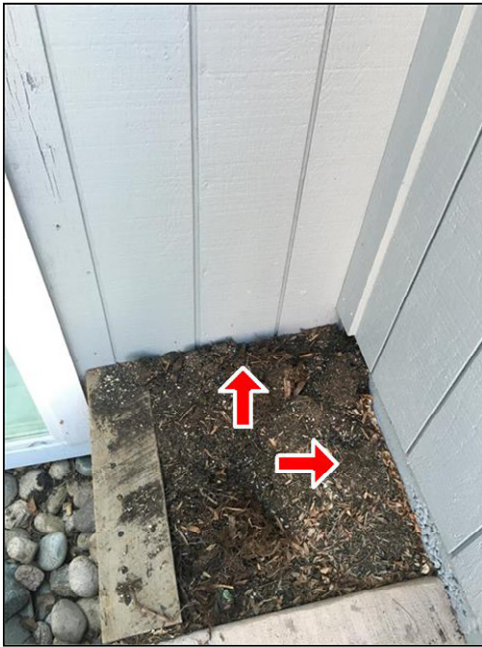
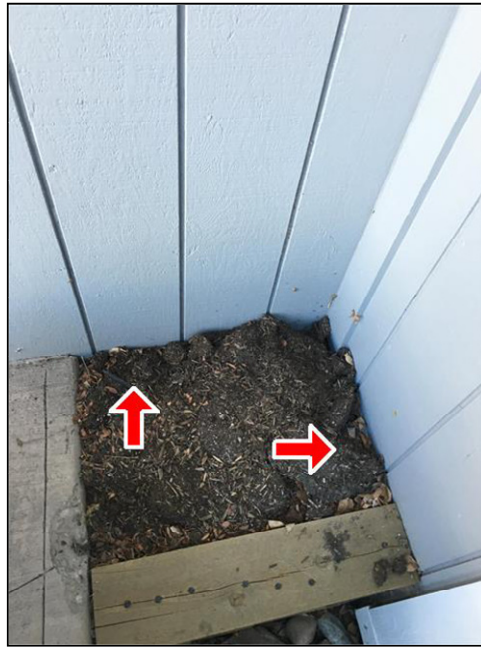
2.4 There are several areas where soils are burring the siding material. This will lead the siding to deteriorate and rot away. Areas that had siding buried-flower boxes by the front door and east side of the house

2.4 Item 1(Picture) planter box burring siding

2.4 Item 2(Picture) planter box burring sidingz

There are several areas where soils are burring the siding material. This will lead the siding to deteriorate and rot away. Areas that had siding buried-flower boxes by the front door and east side of the house

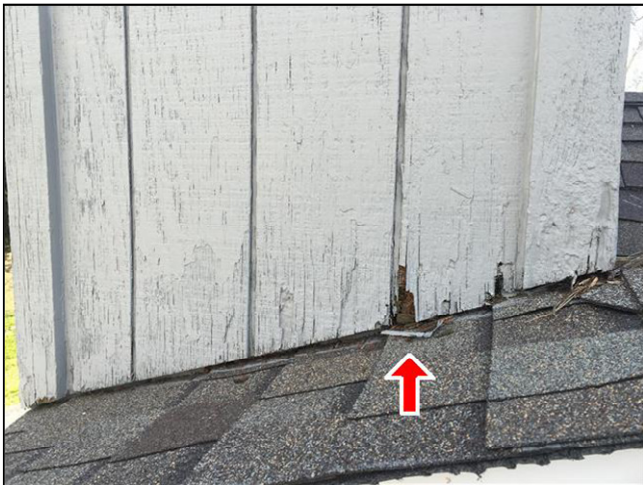
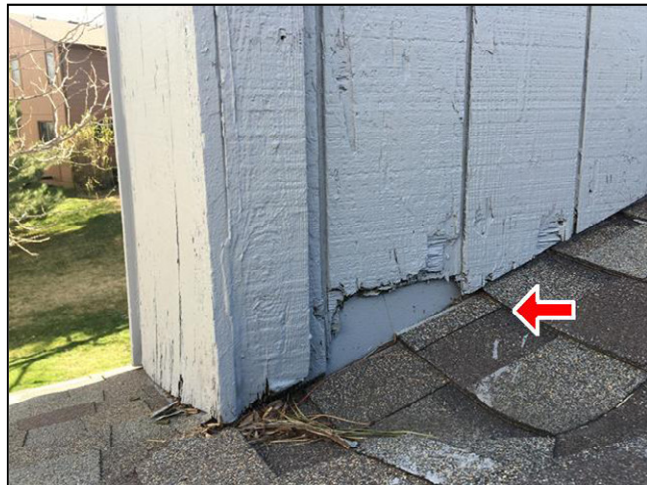
The siding on the chimney is starting to show signs of deterioration along the roof.

2.4 Item 3(Picture) deteriorating siding on the chimney

2.4 Item 4(Picture) back side of chimney

The siding on the chimney is starting to show signs of deterioration along the roof.

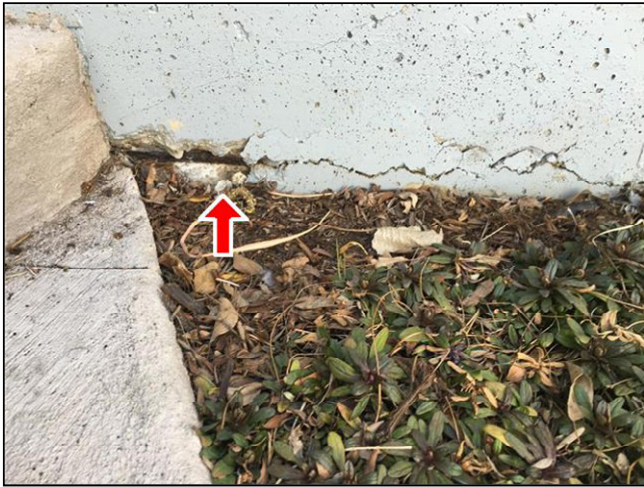
The east side of the garage, south end, has some concrete that has deteriorated and crumbled away. This has exposed the rebar and will eventually deteriorate the rebar completely. The area needs to be sealed and patched.

2.4 Item 5(Picture) Deteriorating concrete, exposed rebar

The east side of the garage, south end, has some concrete that has deteriorated and crumbled away. This has exposed the rebar and will eventually deteriorate the rebar completely. The area needs to be sealed and patched.

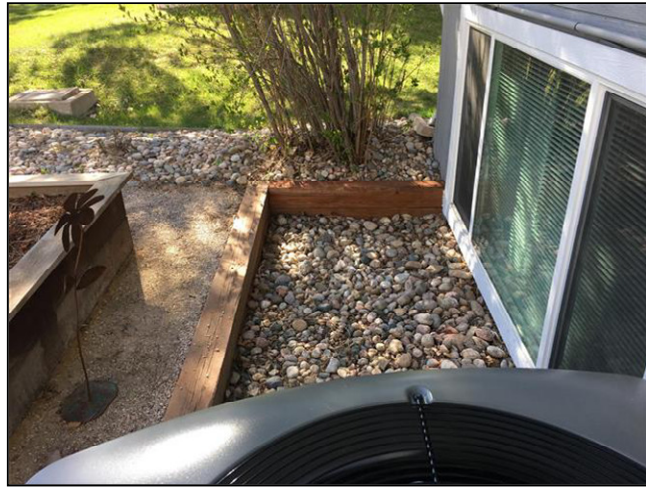
The grading in the south west window well has negative slope and needs to be adjusted so that water will run away from the house instead of towards it.

2.4 Item 6(Picture) negative slope in window well

The grading in the south west window well has negative slope and needs to be adjusted so that water will run away from the house instead of towards it.

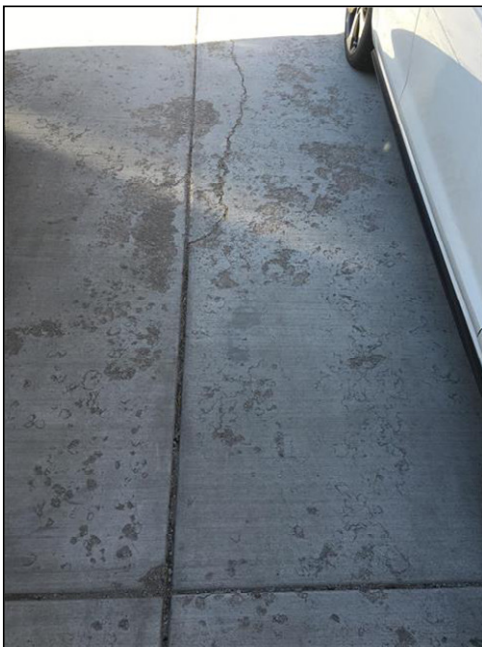
The concrete driveway is starting to flake. It was finished too "hot" and did not cure properly.

2.4 Item 7(Picture) flaking concrete

The concrete driveway is starting to flake. It was finished too "hot" and did not cure properly.

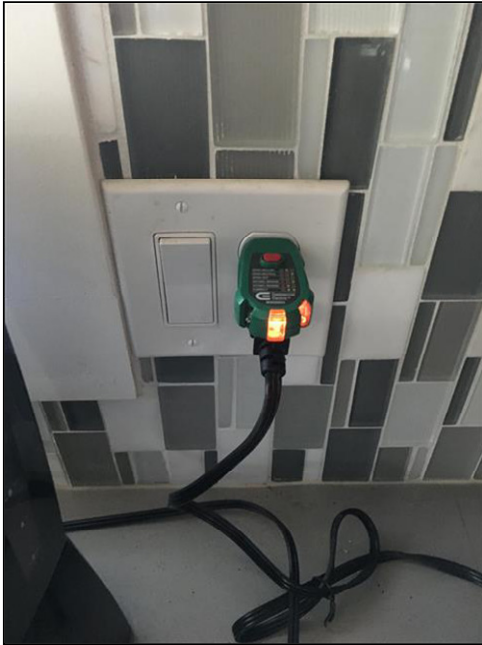
**4.8** The outlets in the kitchen are not GFCI protected. Further evaluation is recommended by a licensed electrician.

4.8 Item 1(Picture) non-protected gfci outlets

The outlets in the kitchen are not GFCI protected. Further evaluation is recommended by a licensed electrician.

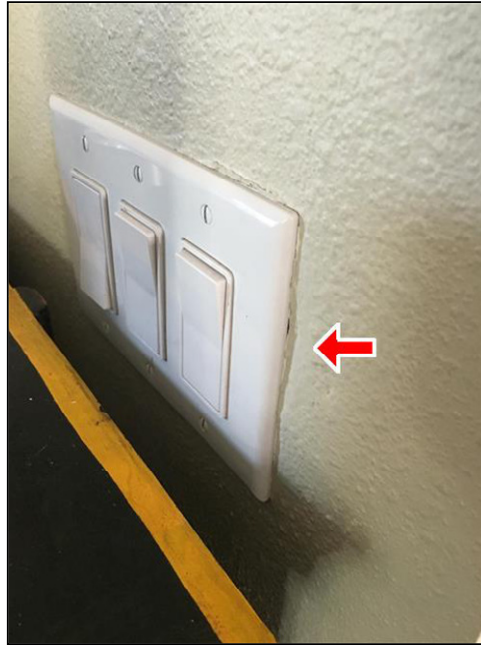
The three way switch for the kitchen is not wired properly. The dining room switch for the kitchen lights must be on in order for the entryway switch to work. Further evaluation is recommended by a licensed electrician.

4.8 Item 2(Picture) kitchen switches

The three way switch for the kitchen is not wired properly. The dining room switch for the kitchen lights must be on in order for the entryway switch to work. Further evaluation is recommended by a licensed electrician.

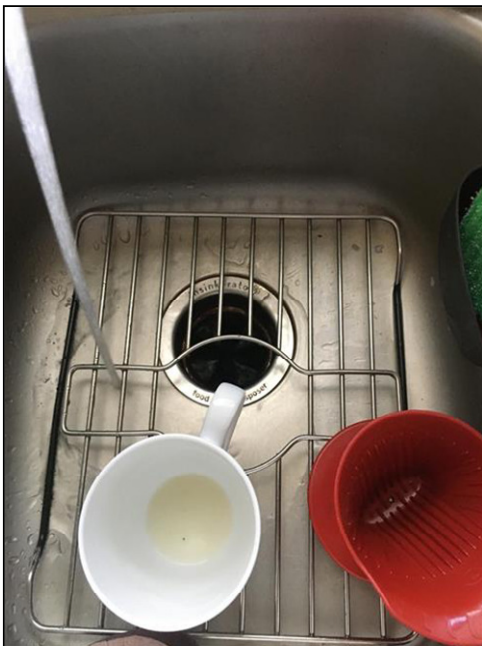
**4.12** The disposal is starting to sound like the bearings may be going out of it. Further evaluation by a licensed plumber is recommended

4.12 Item 1(Picture) disposal

The disposal is starting to sound like the bearings may be going out of it. Further evaluation by a licensed plumber is recommended

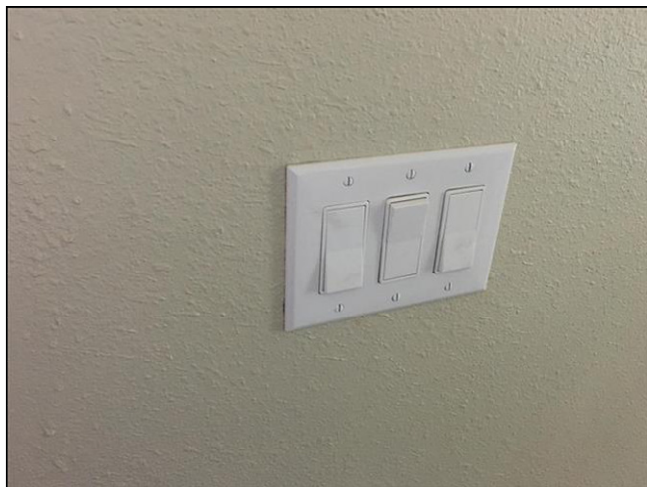
**5.6** The switches for the loft and the hallway are not wired properly. Further evaluation is recommended by a licensed electrician.

5.6 Item 1(Picture) loft/hallway switches

The switches for the loft and the hallway are not wired properly. Further evaluation is recommended by a licensed electrician.

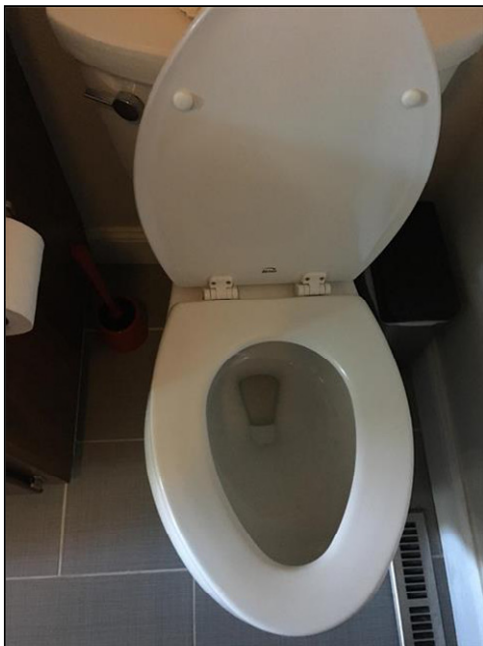
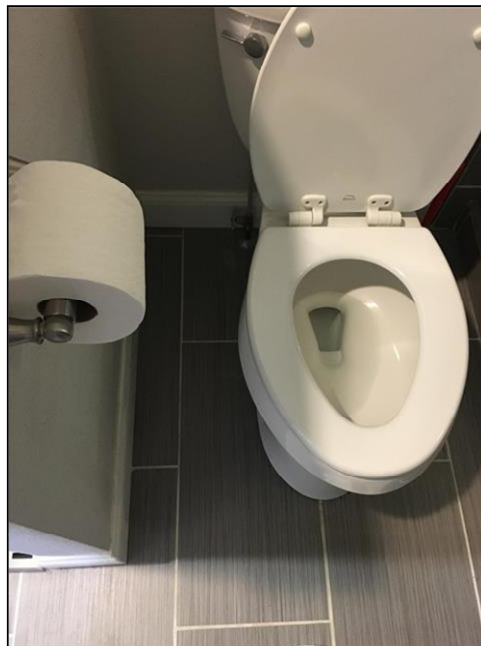
**6.8** The upper stairs main bath and the master bath toilets are loose and need to be tightened. There is a potential that water could penetrate the loose wax ring and cause damage to the subfloor. Further evaluation is recommended by a licensed plumber

6.8 Item 1(Picture) loose toilet-main bath

6.8 Item 2(Picture) loose master bath toilet

The upper stairs main bath and the master bath toilets are loose and need to be tightened. There is a potential that water could penetrate the loose wax ring and cause damage to the subfloor. Further evaluation is recommended by a licensed plumber

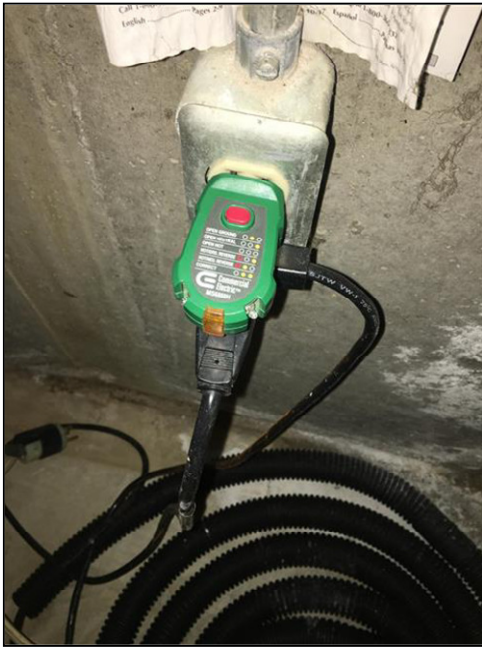
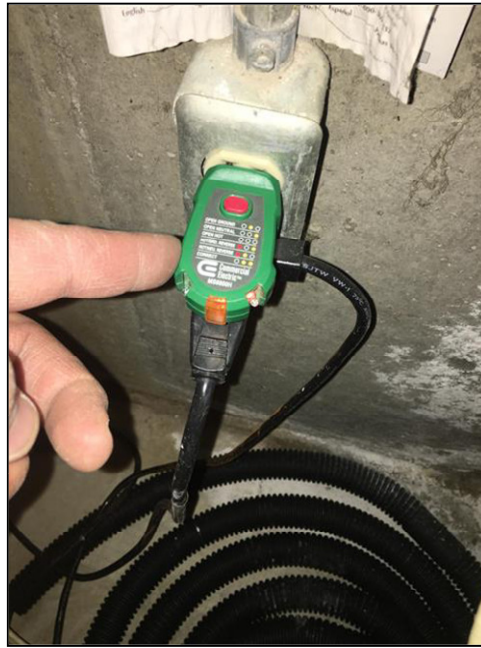
9.4 The top half of the sump pump outlet is not working properly. The contacts are loose and the outlet should be replaced.

9.4 Item 1(Picture) non-working sump outlet

9.4 Item 2(Picture) working sump outlet when pressure is applied

The top half of the sump pump outlet is not working properly. The contacts are loose and the outlet should be replaced.
